# **REPORT OF BUILDING INSPECTIONS TECOLUCA, EL SALVADOR**

Prepared by:  
Global Village Engineers

23 JANUARY, 2001

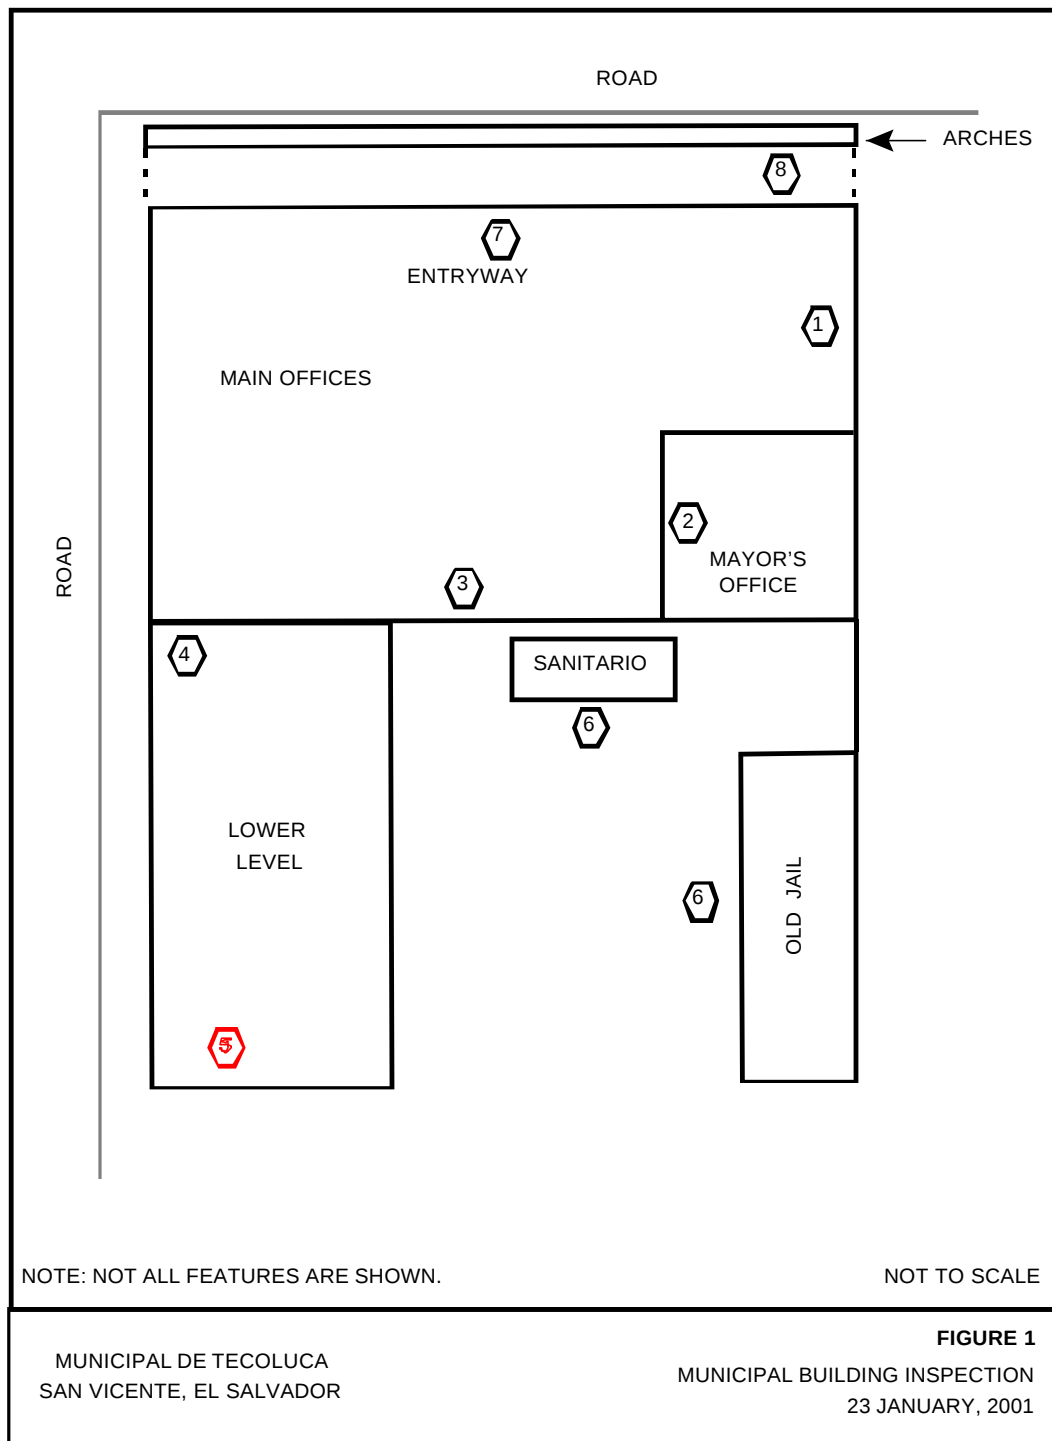
The following specific observations were made, as shown on **Figure 1**:

Area 1: Small cracks in the interior wall plaster, < 1mm wide.

Area 2: Small crack ~1mm wide, from top of partition ~1m toward floor.

Area 3: Crack between floor slab and wall, ~1cm wide. Apparently caused by differential movement between slab on backfill, and wall which has a footing on native soil at the lower level.

Area 4: Corner crack, from floor to top of wall, visible from interior and exterior. This is apparently a separation of the interior wall from the exterior wall.

Area 5: Small vertical cracks on the interior wall from floor to top of wall are apparently due to the collapse of the adjacent adobe brick building onto the exterior of this wall. **This room should not be inhabited until the collapsed building can be removed from contact with the exterior wall.**

- Area 6: In the rear courtyard, the sanitario and old jail buildings were damaged. These structures were not connected to the municipal building, and are scheduled to be removed. They are not impacting the municipal building.
- Area 7: In the main entryway and waiting area of the municipal building, one of the roof steel truss rafters was apparently bent by the earthquake. Both the top and bottom members of the rafter are bent, as well as the truss ties near the exterior wall. This rafter did not appear to be close to failure and the other roof support members were apparently not damaged.
- Area 8: The concrete arches supporting the front sidewalk roof had small cracks ~1-2mm wide across the middle of each column and at the peak of each archway. The arch wall appeared straight and plumb to the eye.

1. [Figure 1, Area 5] The rear room should not be inhabited until the collapsed building can be removed from contact with the exterior wall.
2. The bent rafter in the main room should be removed and replaced before the permanent roof tiles and suspended ceiling are replaced. In the interim, steel laminate roofing which is lighter should be used to keep out weather.

3. [Figure 1, Area 4] The corner crack should be sealed from the exterior to prevent rainwater from entering the structure.
4. The plaster should be removed from all small cracks to allow an inspection of damage underneath. Loose mortar should be removed and the bricks re-mortared before replastering and painting. This applies to the building walls and the front arches. Note: more significant damage may become apparent after the plaster is removed, such as crushed bricks. In that event, an additional inspection by an engineer or brick mason experienced in building construction should be conducted to determine if more extensive repairs are needed.

5. The exterior sanitario and old jail should be removed as planned.

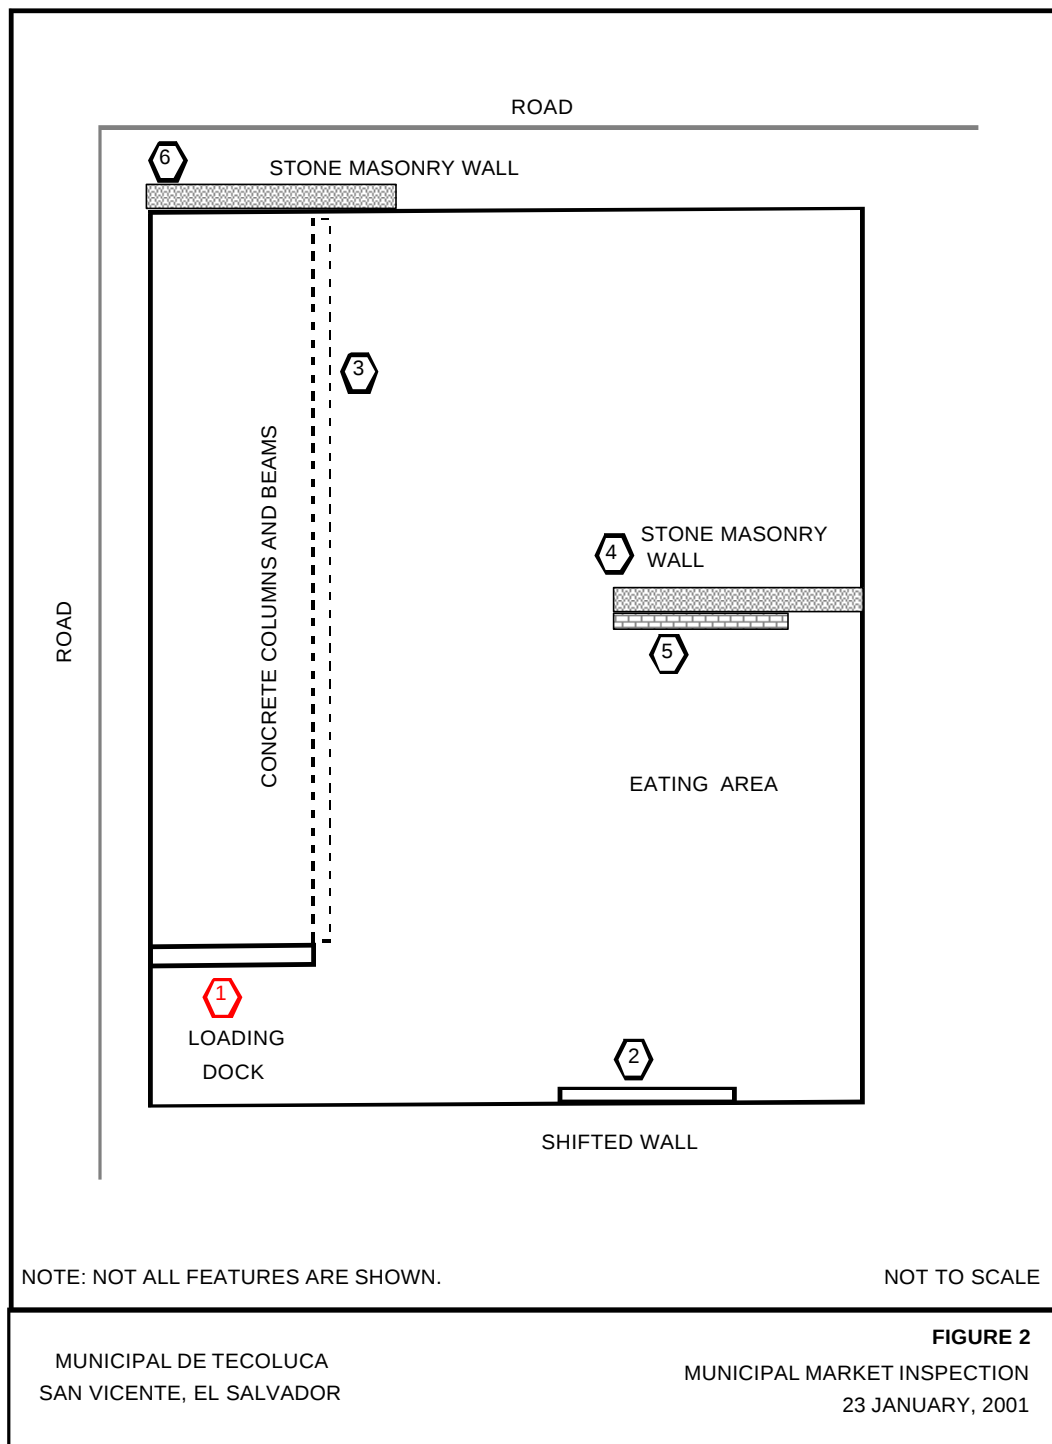
The following specific observations were made, as shown on **Figure 2**:

- Area 1: The inside wall adjacent to the loading dock apparently moved significantly during the earthquake. The wall has separated from supporting sidewalls and columns, and is leaning toward the loading dock area. The only apparent support for the wall is a steel truss extending between the loading dock walls, that also supports the dock doors. **This wall represents a dangerous condition, and should be removed. All access to the loading dock should be restricted until the wall is removed.**

- Area 2: A portion of exterior wall above the supporting sill has shifted out. The shifted piece is attached to steel stringers that support roof tiles, so further shifting may cause roof damage.

- Area 3: One of the concrete beams supporting the drainage box had a horizontal crack along the middle of the beam. This crack appeared to be minor (<1mm wide), and not a structural problem.

- Area 4: The stone masonry wall that penetrates the middle of the building (adjacent to the eating area) extends above the roofline. Several of the large stones at the top of the wall came loose during the earthquake, and fell through the tile roof. It appears that other stones at the top of the wall may be loose. The wall should be repaired to keep more stones from falling. The wall as a whole appears stable.

Area 5: A brick/plaster wall against the stone wall (adjacent to the eating area) has two long diagonal cracks. These appear to be due to loosened mortar between bricks. The wall otherwise appears straight and plumb.

Area 6: An exterior stone masonry wall, adjacent to but not part of the market building wall, is tilted out toward the sidewalk and street. This wall may continue to fall out.

1. [Figure 2, Area 1] The loading dock entrance should be closed immediately. The damaged wall should be replaced entirely and not repaired in-place.
2. [Figure 2, Area 2] The portion of shifted exterior wall should be repaired, but does not appear to be an immediate danger. This portion of wall could be removed and replaced, or possibly pushed back into place and secured from further movement by steel or concrete support installed on the exterior.

3. [Figure 2, Area 4] The top of the middle stone masonry should be repaired before inhabitants are allowed in this area of the building.
4. [Figure 2, Area 5] The eating area brick wall plaster should be removed from the cracks to allow an inspection of damage underneath. Loose mortar should be removed and the bricks re-mortared before replastering and painting. Note: more significant damage may become apparent after the plaster is removed, such as crushed bricks. In that event, an additional inspection by an engineer or brick mason experienced in building construction should be conducted to determine if more extensive repairs are needed.

5. [Figure 2, Area 6] The exterior stone masonry wall should be removed, with access restricted next to the wall until this occurs.

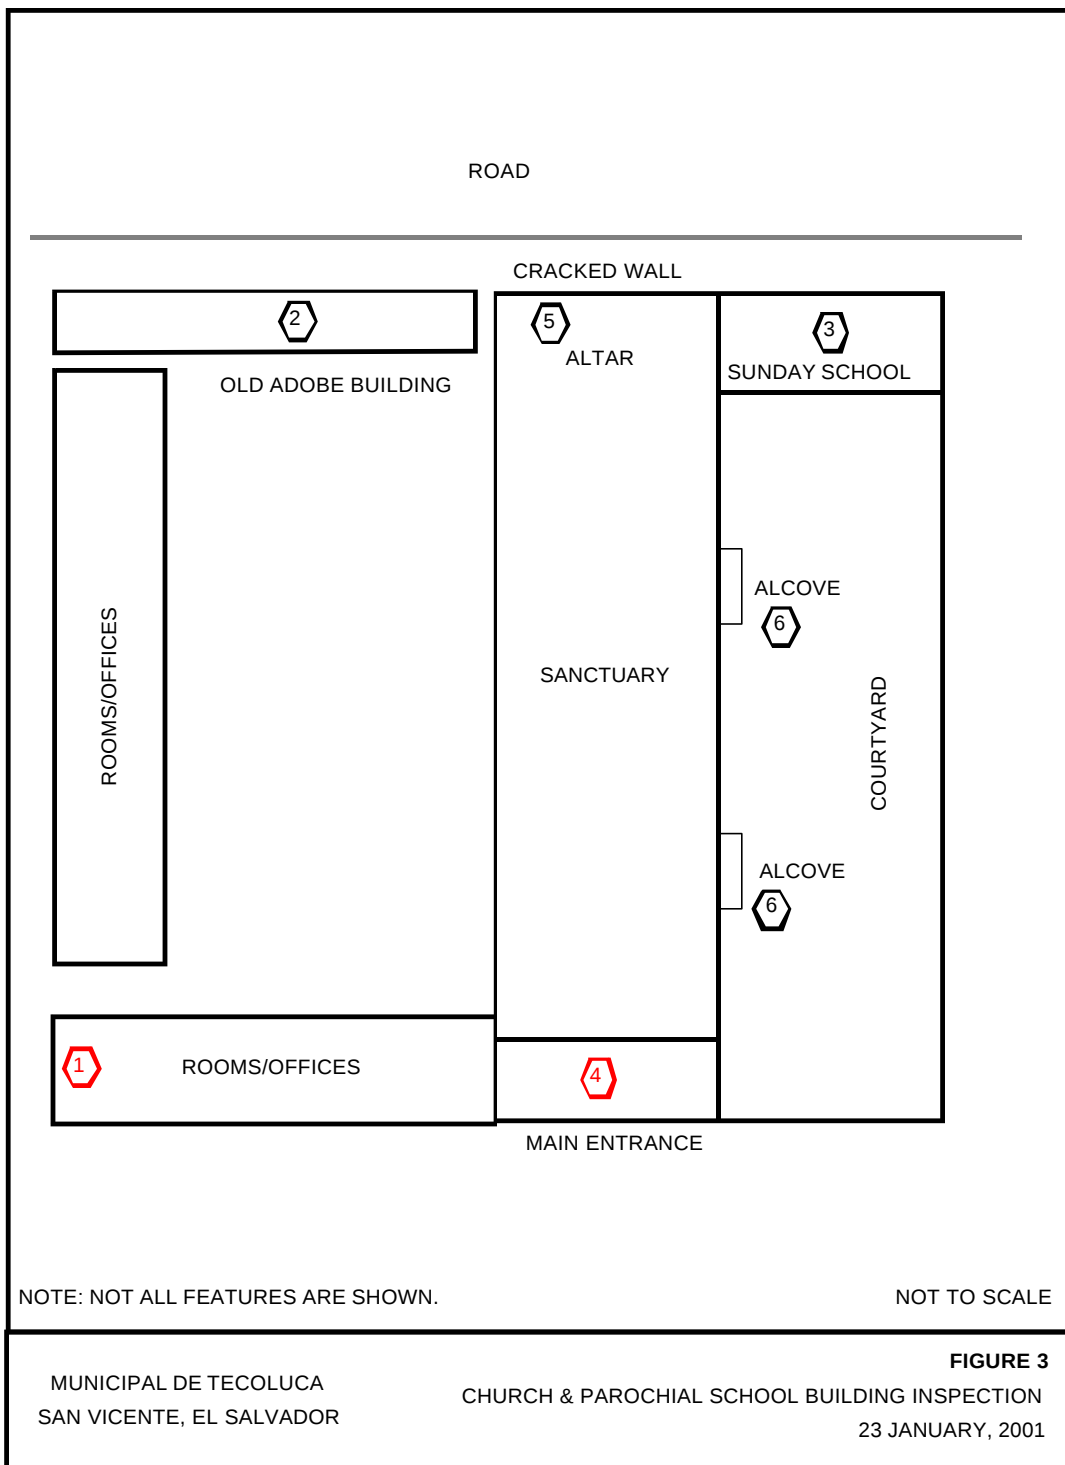
The following specific observations were made, as shown on **Figure 3**:

- Area 1: Small vertical cracks on the interior wall of the secretarial office from floor to top of wall are apparently due to the collapse of the adjacent adobe brick building onto the exterior of this wall. **This room should not be inhabited until the collapsed building can be removed from contact with the exterior wall.**
- Area 2: The old adobe buildings next to the sanctuary appeared severely damaged. They do not appear to be impacting the other buildings.
- Area 3: The Sunday School structure had concrete missing from the top of the wall where steel roof rafters attach. This condition does not appear to be a structural problem.

Area 4: The following was observed in the main entranceway of the sanctuary:

- a. The entire rear section appeared structurally detached from the sanctuary sidewalls. Cracks 1-5mm wide from floor to top of wall were observed in both corners between the sanctuary walls and the columns of the rear section. These cracks extended from the interior through to the exterior, indicating full separation.
- b. The interior rear wall had areas where plaster and portions of brick and mortar were missing, particularly at the peak of the arch over the main doors. Similar damage occurred on the exterior of the wall over the arch peak. Large sections of plaster had fallen from the exterior of the rear wall.
- c. The concrete beams on the interior of the rear section had damage along the bottom of the beam, where concrete had come off revealing the steel reinforcement.
- d. Small cracks <1mm wide were evident between the stairs to the towers and the side wall.

Area 5: In the front of the sanctuary, the entire altar had shifted 5-10 cm to the front toward the wall. The tiled raised step behind the altar was damaged around its edges. The front wall had a long horizontal crack 1-2 cm wide, extending from the top of the sidewall. This wall showed no evidence of cracking or movement when viewed from the exterior.

Area 6: On the courtyard side of the sanctuary there are two attached alcoves that open into the sanctuary. The foundations of these alcoves were damaged.

1. [Figure 3, Area 1] The secretarial room should not be inhabited until the adjoined collapsed building can be removed from contact with the exterior wall.

2. [Figure 3, Area 2] The old adobe buildings should be removed and should not be used or inhabited.
3. [Figure 3, Area 3] The concrete on the top of the Sunday School walls should be repaired; however, there does not appear to be immediate danger from this condition.

4. [Figure 3, Area 4] The main entranceway of the sanctuary should not be used until a more detailed assessment can be made by an engineer or contractor experienced in church building construction. Churches in other towns with the same design suffered major damage to this part of the building, and there is concern that further aftershocks could result in additional significant damage to this church. The church officials that accompanied the inspection indicated that a side entrance could be used for services.

5. [Figure 3, Area 5] The front wall of the church should have the plaster removed from the cracks to allow an inspection of damage underneath. Loose mortar should be removed and the bricks re-mortared before replastering and painting. Note: more significant damage may become apparent after the plaster is removed, such as crushed bricks. In that event, an additional inspection by an engineer or brick mason experienced in building construction should be conducted to determine if more extensive repairs are needed.
6. The raised step to the altar should be repaired before the altar is repositioned.
7. [Figure 3, Area 6] The exterior foundations under the sanctuary alcoves should be repaired to prevent separation of the alcoves from the sanctuary wall.
